Manhole Inspection Summary

Manhole # S69C1_006MH

Insp Date: **12/1/08 2:31 PM**

Location Address: **Cleveland Ave.**

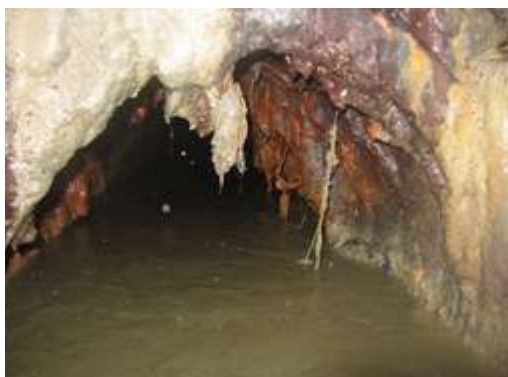
Defect 1

Encrustation of O12 pipe and seal

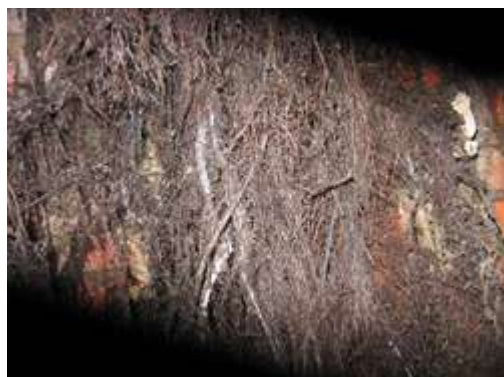
Defect 9

Roots from corbel

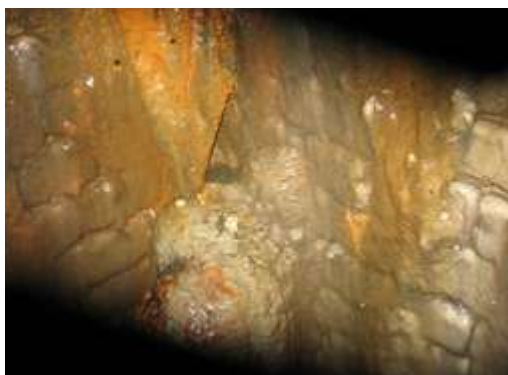
Defect 8

Wall deterioration

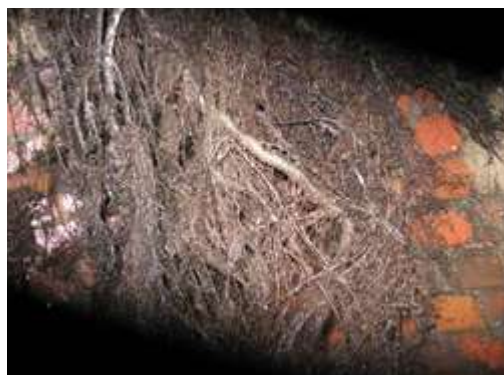
Defect 11

roots

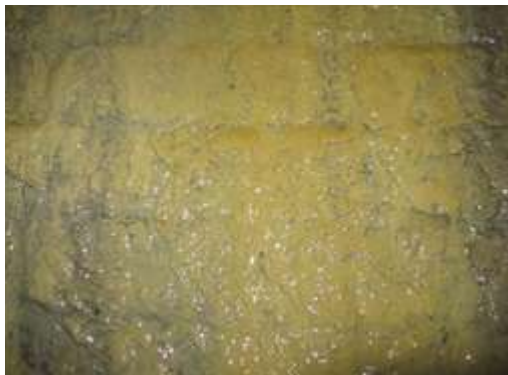
Defect 7

Wall deterioration

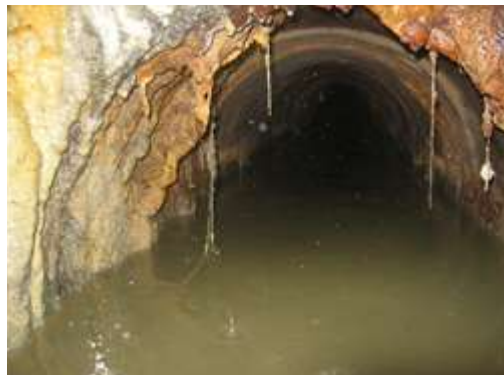
Defect 3

Encrustation of I6 pipe and seal

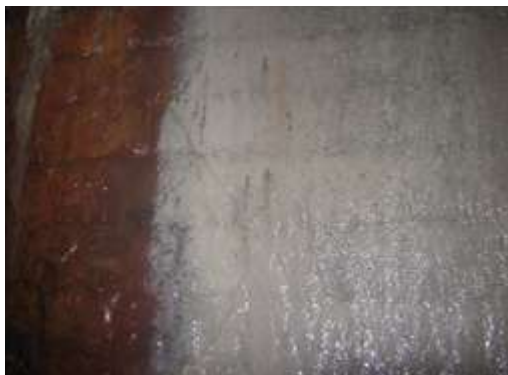
Defect 4

Infiltration of wall

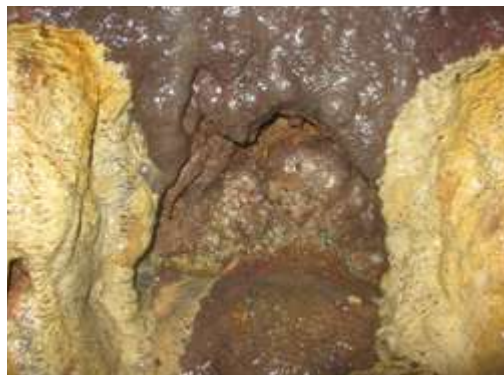
Defect 2

Encrustation of wall

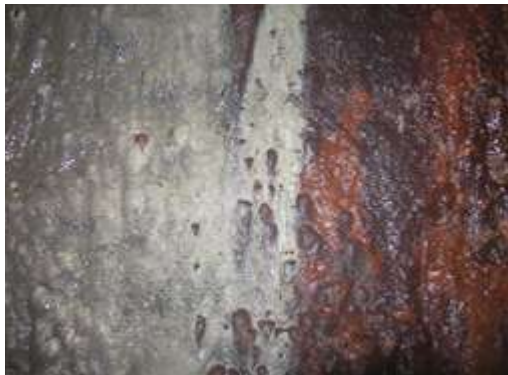
Defect 6

Encrustation

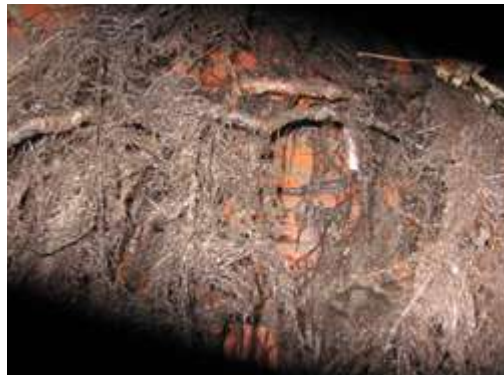
Defect 10

Root from wall

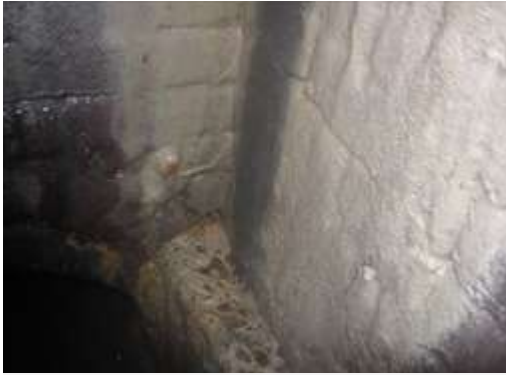
Defect 5

Infiltration of barrel

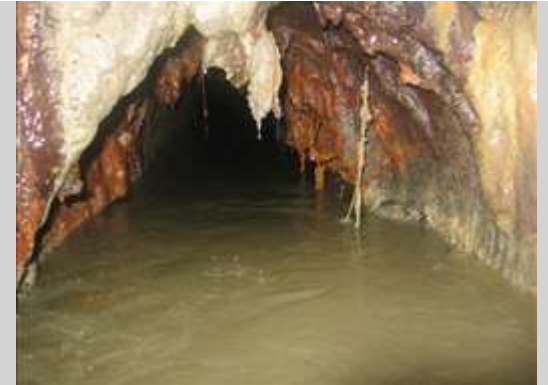
12 O'Clock Outflow

Pipe Height: **30** (in.) Rod and Bar (Angled)
Pipe Material: **Concrete** ☐ Pipe Lined
Invert Depth: **37.67** (ft.) Flow Characteristics: **Fast**
Deposits: ☒ None ☐ Mud ☐ Gravy ☐ Debris ☐ Grease
Silt Depth: (in.) Deposits Extent:
Infiltration: **Weeper** Pipe Seal Cond: **Cracked**

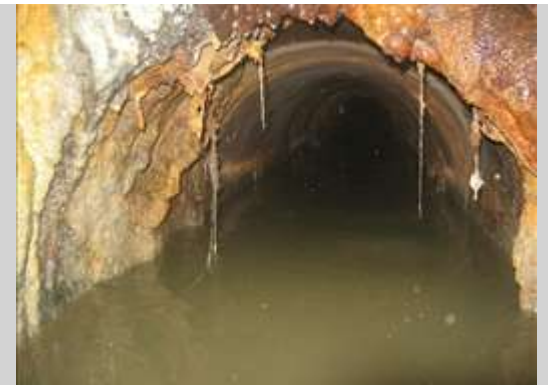
6 O'Clock Inflow

Pipe Height: **30** (in.) Rod and Bar (Angled)
Pipe Material: **Concrete** ☐ Pipe Lined
Invert Depth: **37.50** (ft.) Flow Characteristics: **Fast**
Deposits: ☒ None ☐ Mud ☐ Gravy ☐ Debris ☐ Grease
Silt Depth: (in.) Deposits Extent:
Infiltration: **Evidence** Pipe Seal Cond: **Cracked**

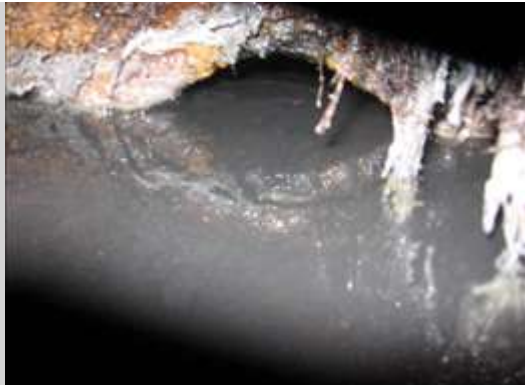
8 O'Clock Inflow

Deposits: ☐ None ☒ Mud ☒ Sludge ☒ Debris ☒ Grease

Silt Depth: **6** (in.) Deposits Extent: **Medium**

Infiltration: **Evidence** Pipe Seal Cond: **Cracked**
